# Manhole Inspection Summary

## Manhole # S23AA1001MH

Insp Date: **1/29/07 2:01 PM**

**Location** Address: **3617 BUENA VISTA AVE**

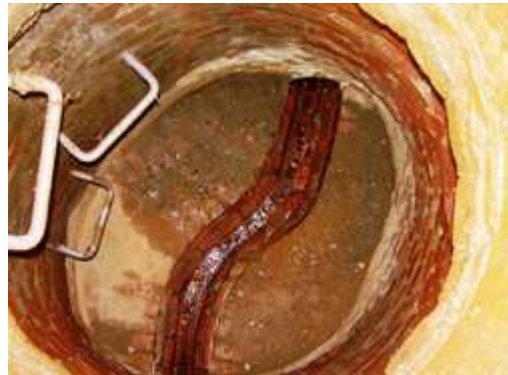
Top View

Bench debris.

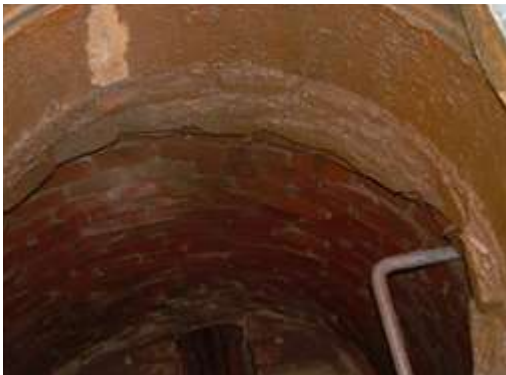
Defect

Condition: ☐ Sound ☐ Cracked ☒ **Leaks**

Infiltration: ☐ None ☒ **Joint** ☐ Cracks ☐ Mortar ☐ Roots ☐ Wall

Infiltration: ☐ None ☐ Joint ☐ Cracks ☒ **Mortar** ☐ Roots ☒ **Wall**

Frame leaks. Frame offset. Adjustment deterioration and infiltration. Barrel infiltration.

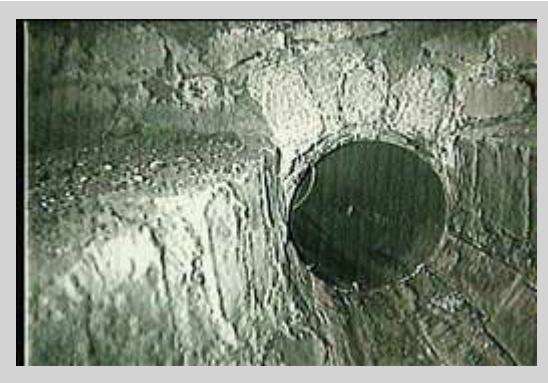
Pipe Out @ 12 O'Clock

Barrel deterioration and infiltration. Channel deterioration.

Infiltration: **Evidence** Pipe Seal Cond: **Unknown**

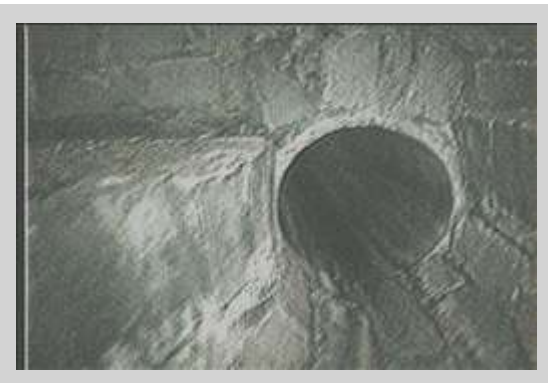
Pipe In @ 6 O'Clock

Barrel deterioration and infiltration. Channel deterioration.
